VEBKO ONLINE HELP

# Overcurrent Error Board 2 Part2

| Section | <b>Troubleshooting</b> |

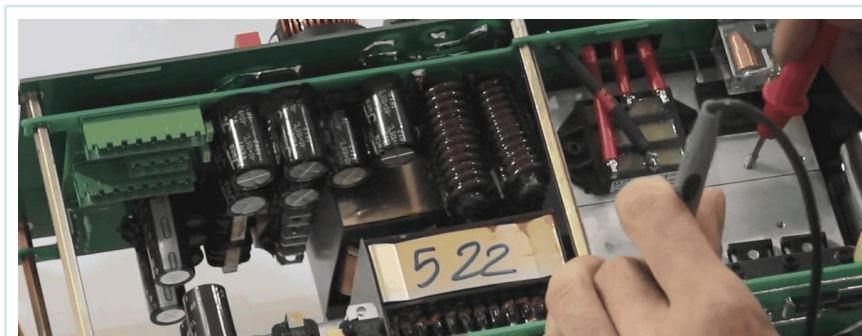
Figure 13

Now we want to make sure that there is no body connection between the IGBT and heat sink. We set the multimeter at ohm mode. We take an IGBT test from the middle pin of IGBT and the heat sink should be Overload. Then we test all IGBTs following the same procedure to ensure that there is no connection. So here the replacement of the IGBT ends and now we can close the Main Switching and take a test to see whether the problem has been solved or not.
